Ice/Frost/Debris Assessment For Space Shuttle Mission STS-27R

(NASA-TM-102144) ICE/FROST/DEBRIS
ASSESSMENT FOR SPACE SHUTTLE MISSION
STS-27R, DECEMBER 2, 1988 (NASA) 200 p
CSCI 22B

ICE/FROST/DEBRIS ASSESSMENT
FOR
SPACE SHUTTLE MISSION
STS-27R
DECEMBER 2, 1988

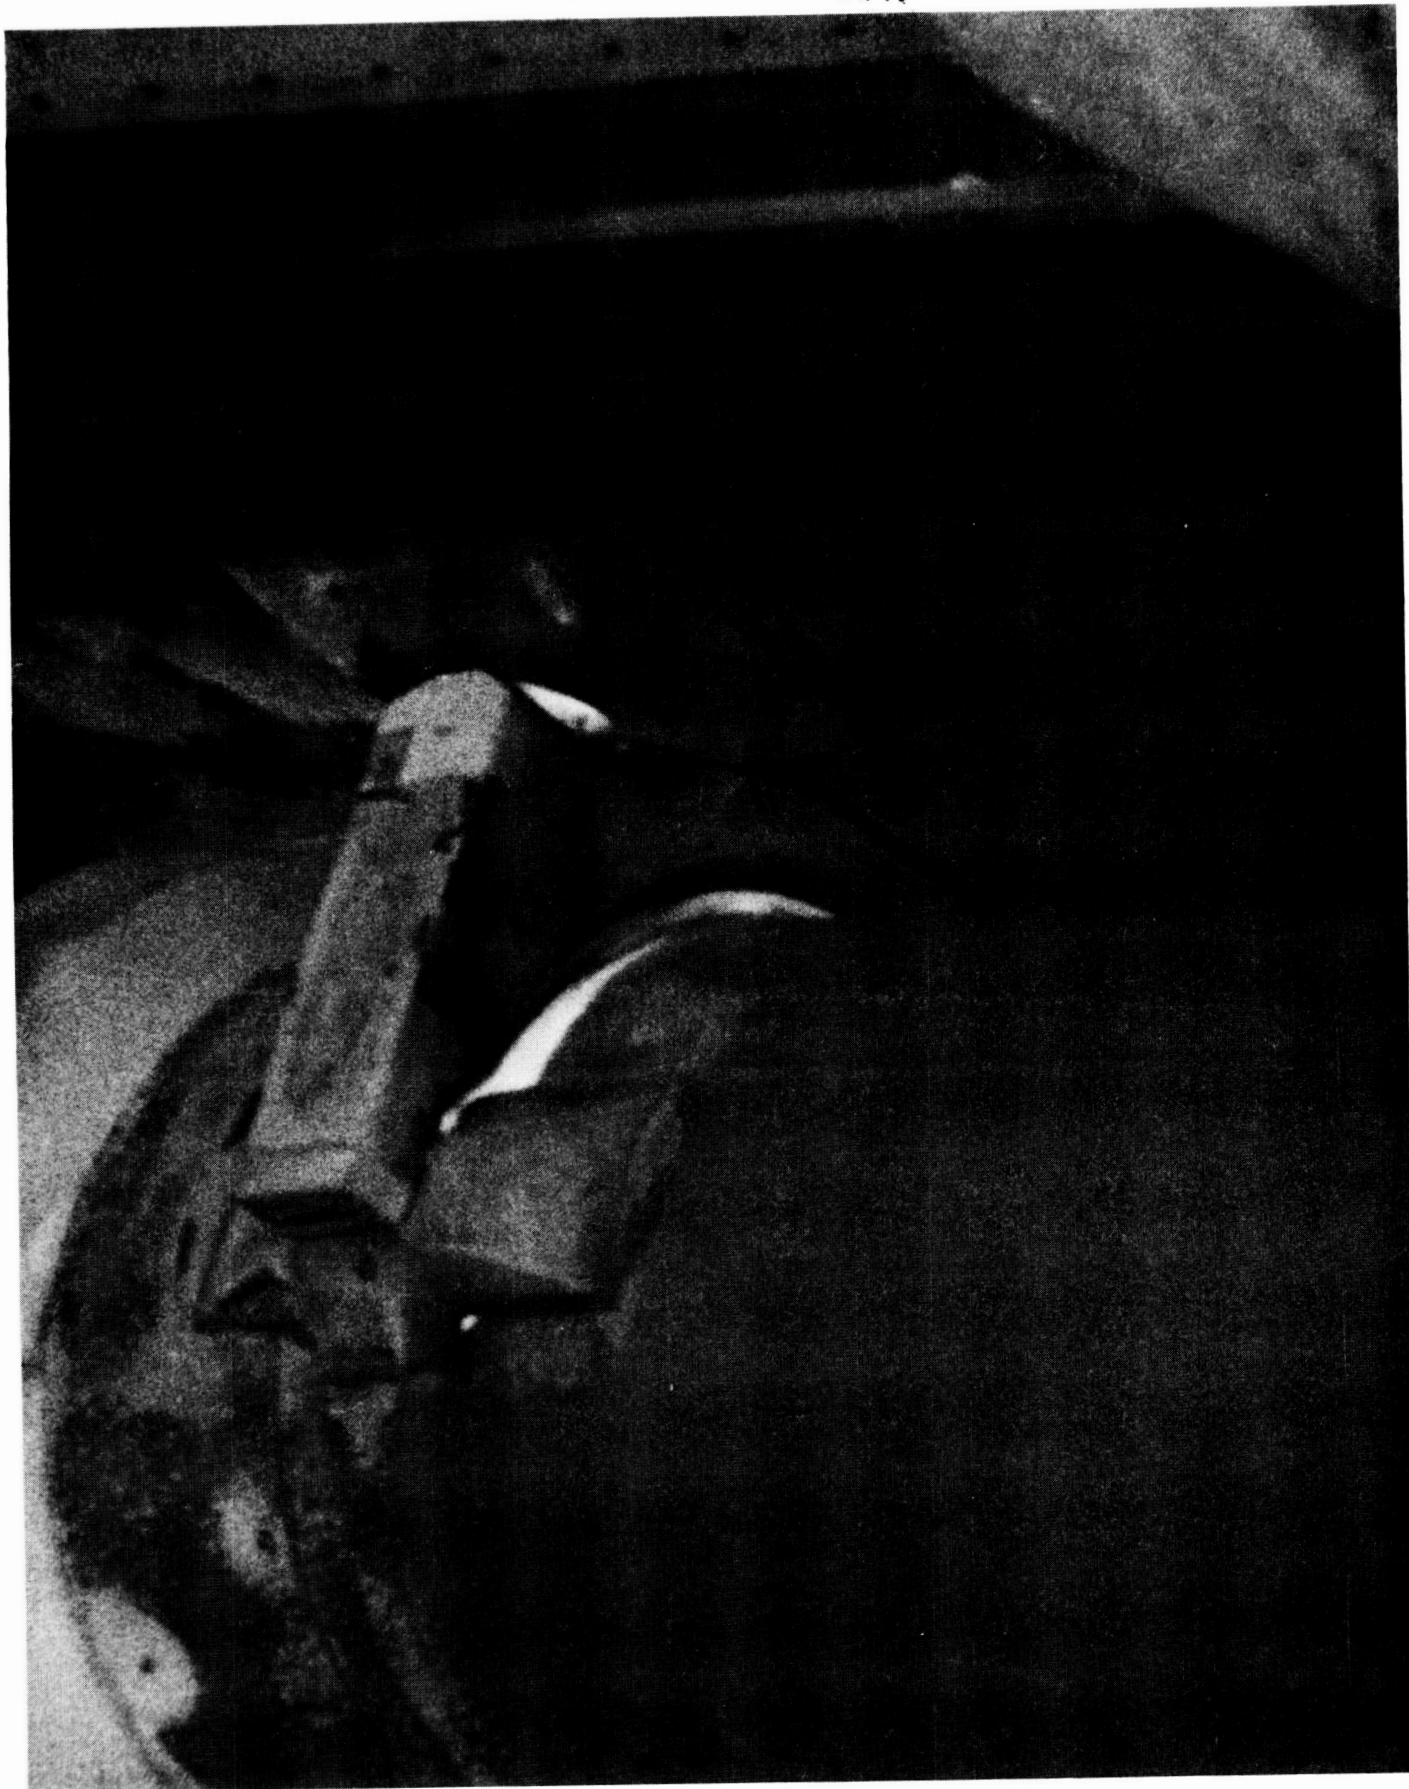
ICE/FROST IN LO2 FEEDLINE SUPPORT BRACKET XT 1871

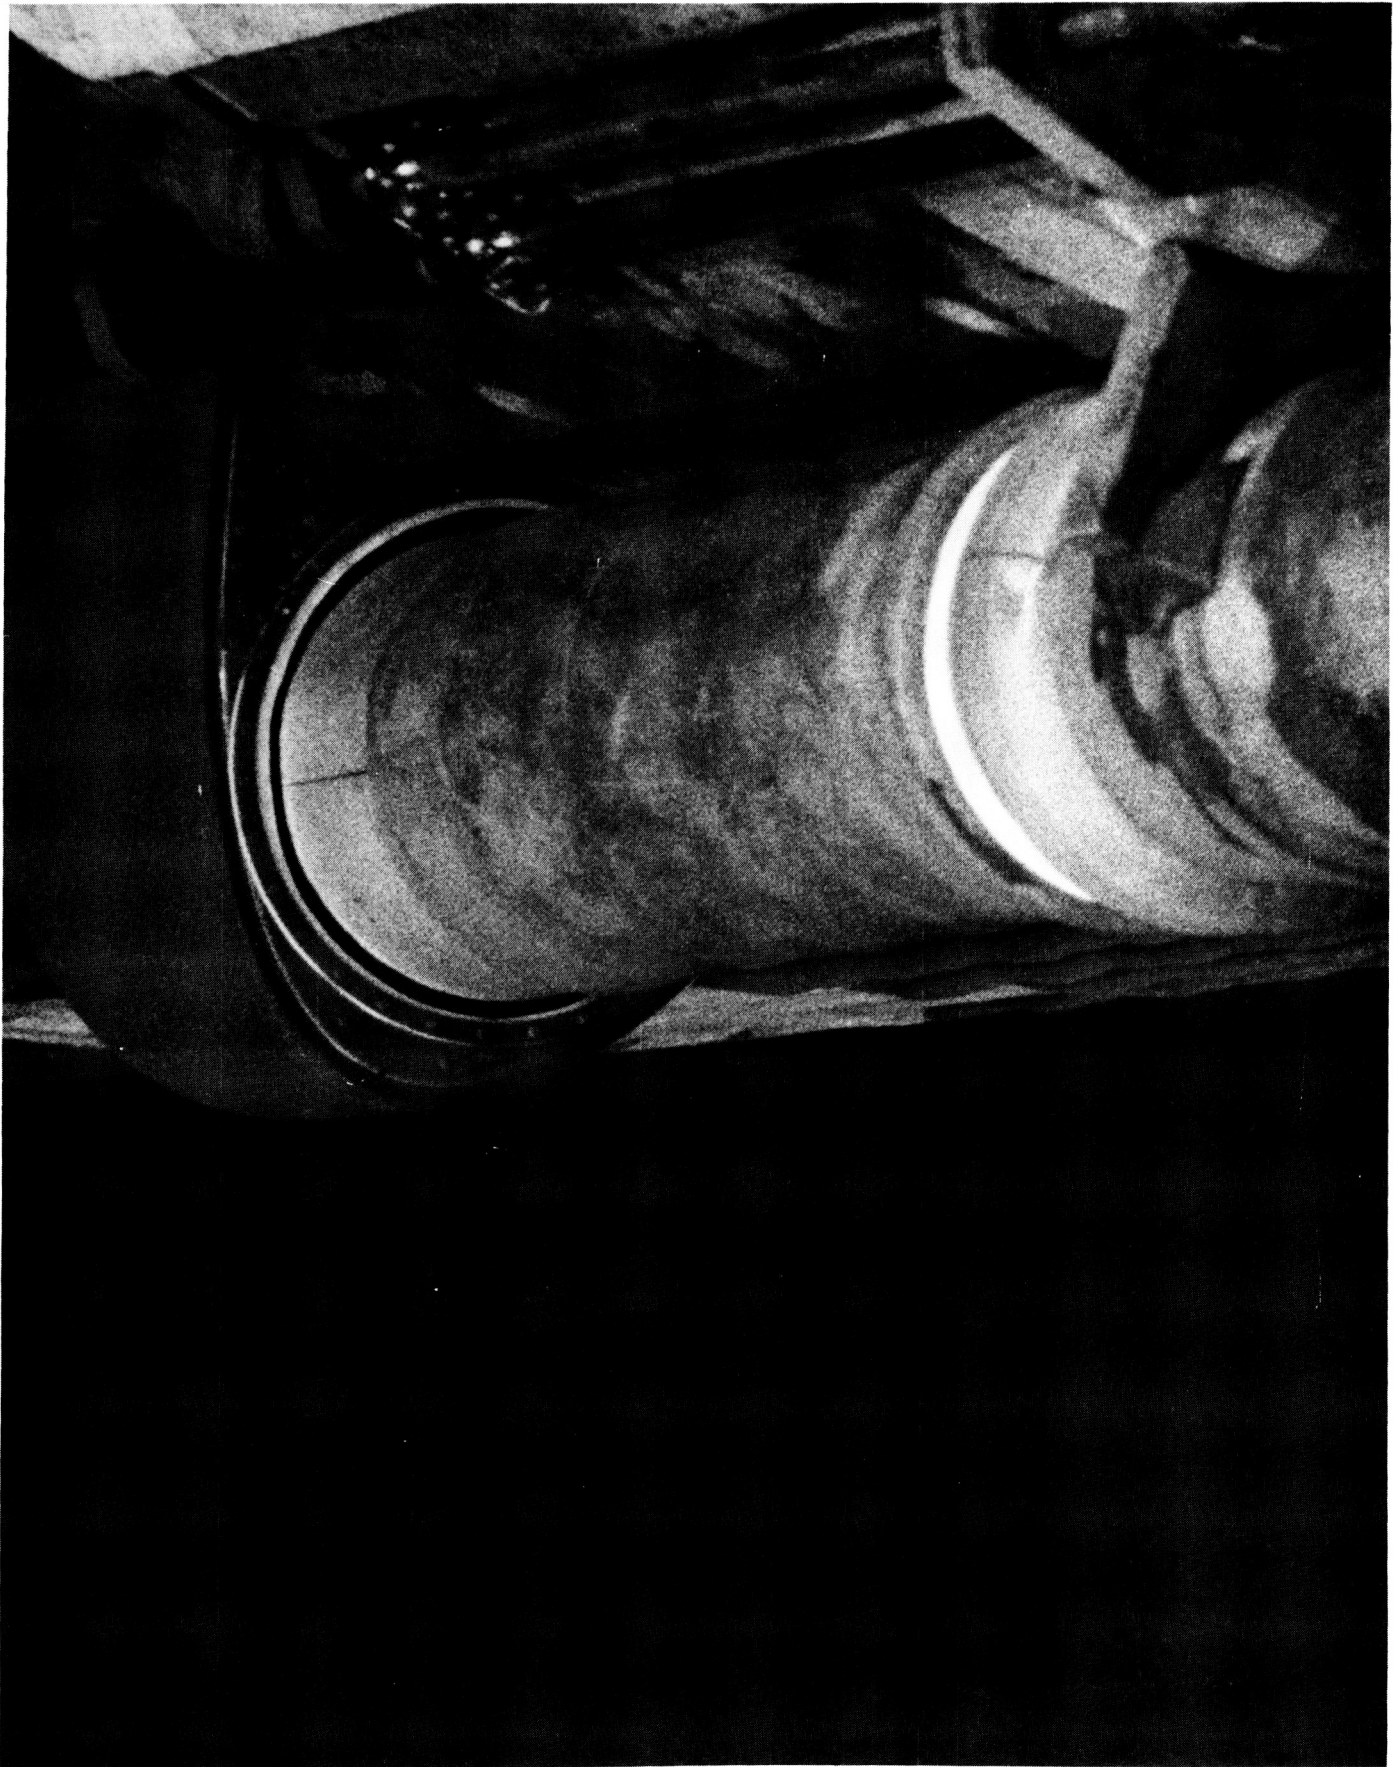
ICE/FROST ACCUMULATION IN LO2 FEEDLINE BELLOWS AT XT 1106

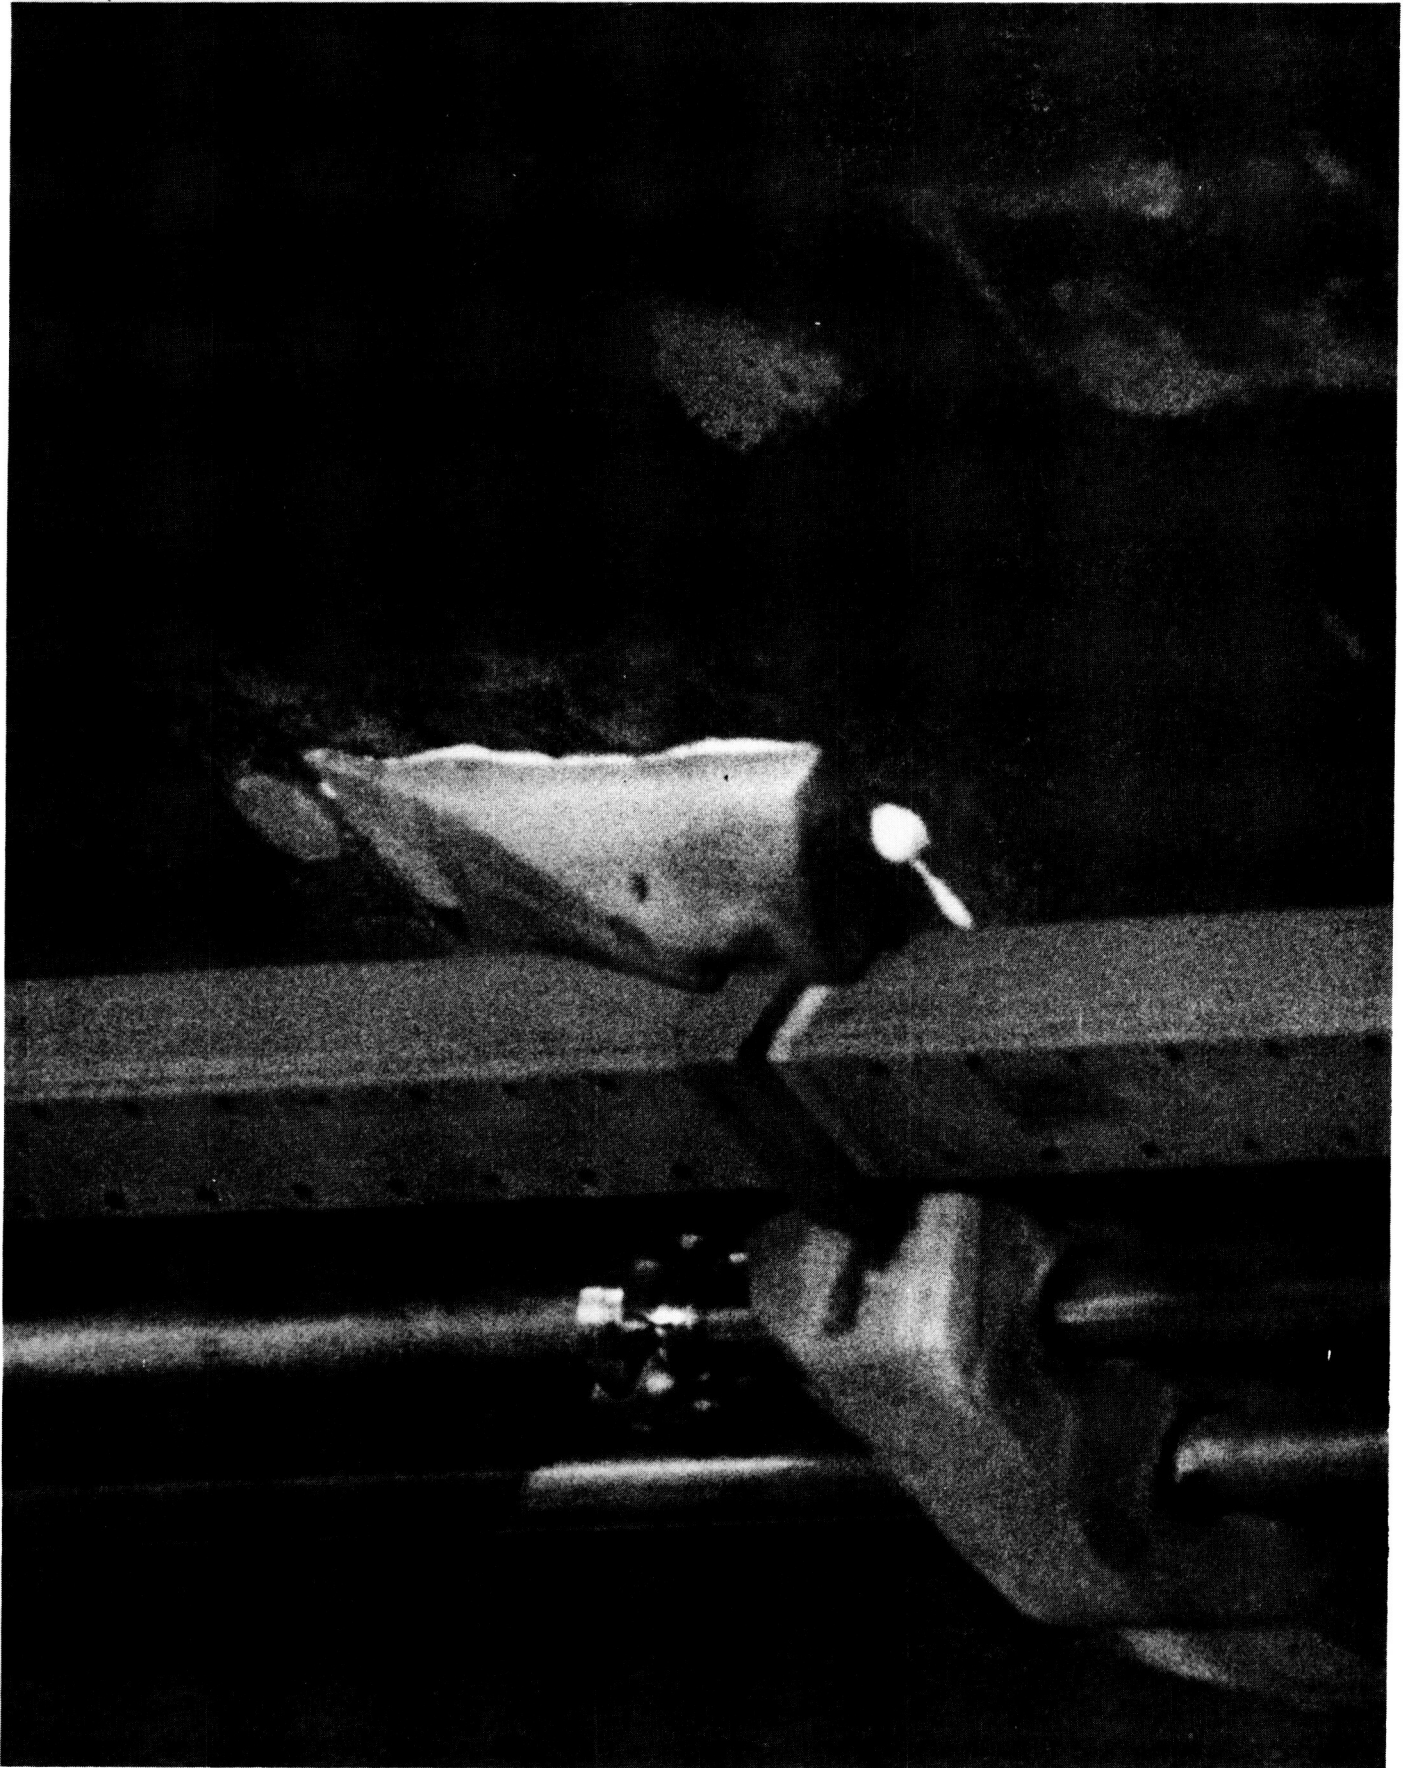
FROST ON CABLE TRAY RAMP TO ACREAGE INTERFACE

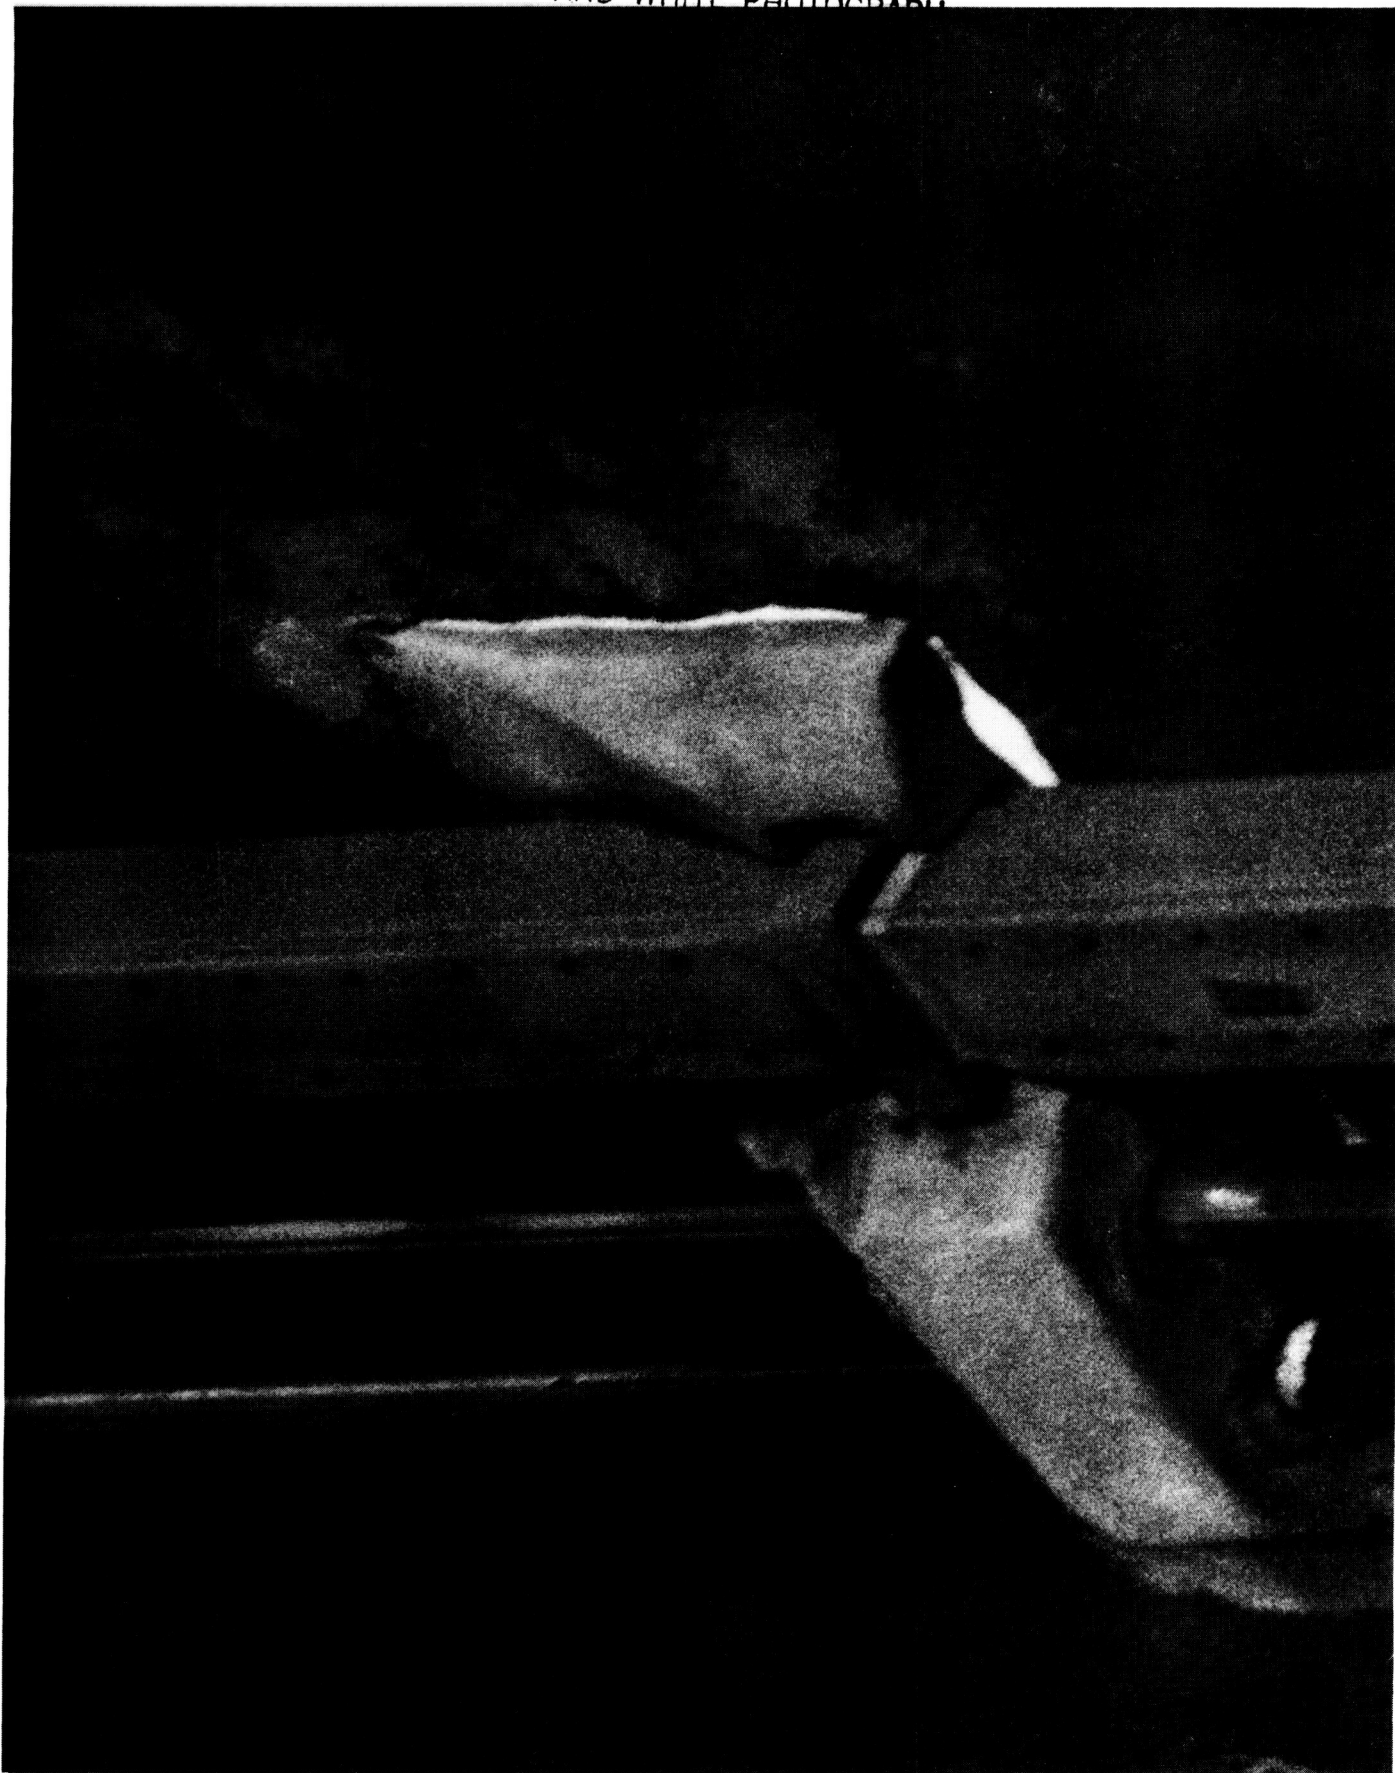
FROST ON CABLE TRAY RAMP TO ACREAGE INTERFACE.
TPS RESIDUE IS VISIBLE ON PRESSLINE.

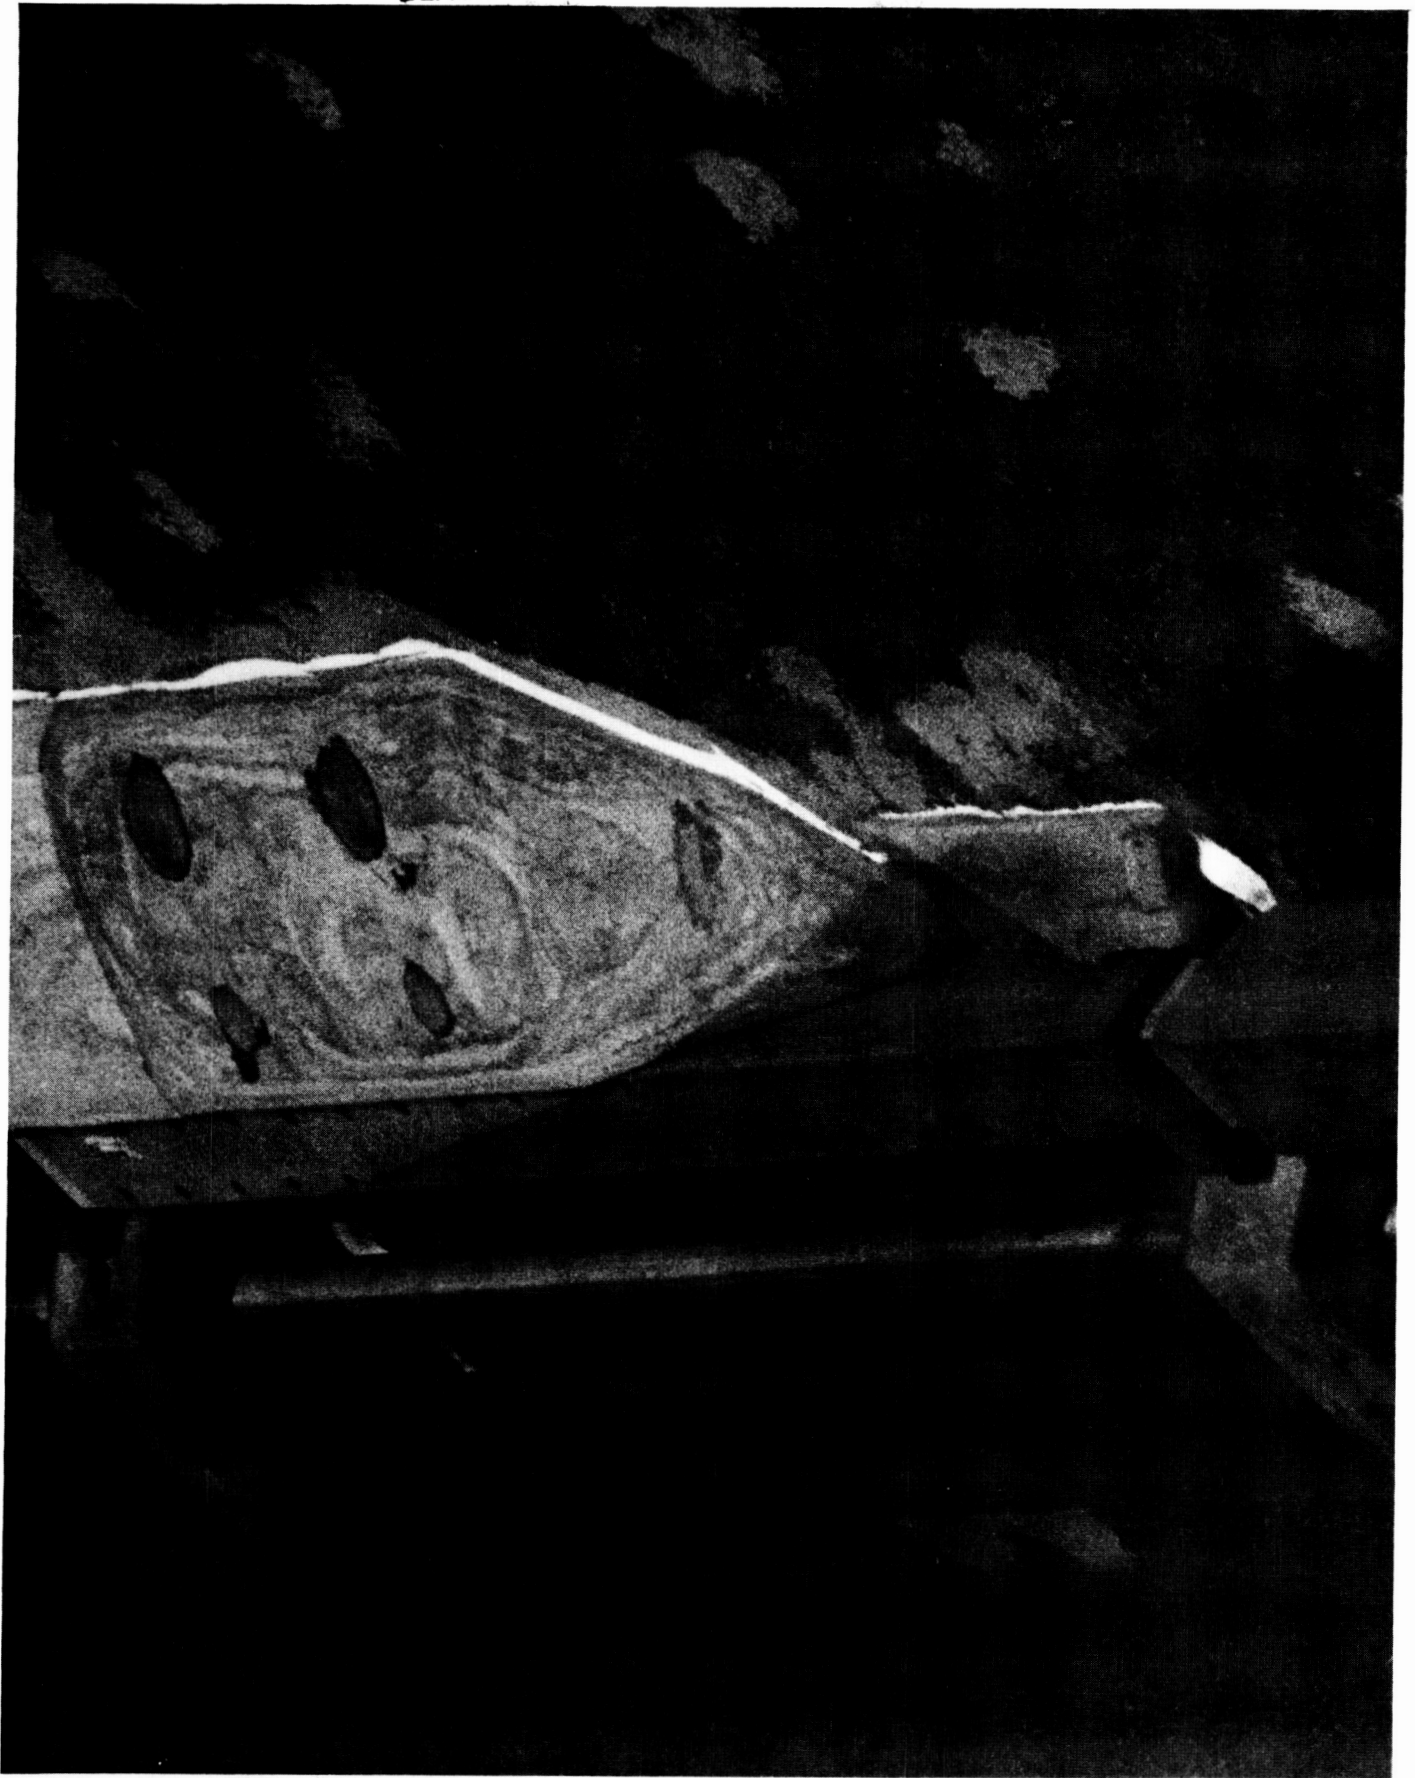
FROST ON LH2 PAL RAMP TO ACREAGE INTERFACE, CABLE TRAY RAMP
TO ACREAGE INTERFACE, AND AFT OF GOX PRESSLINE BARRYMOUNT

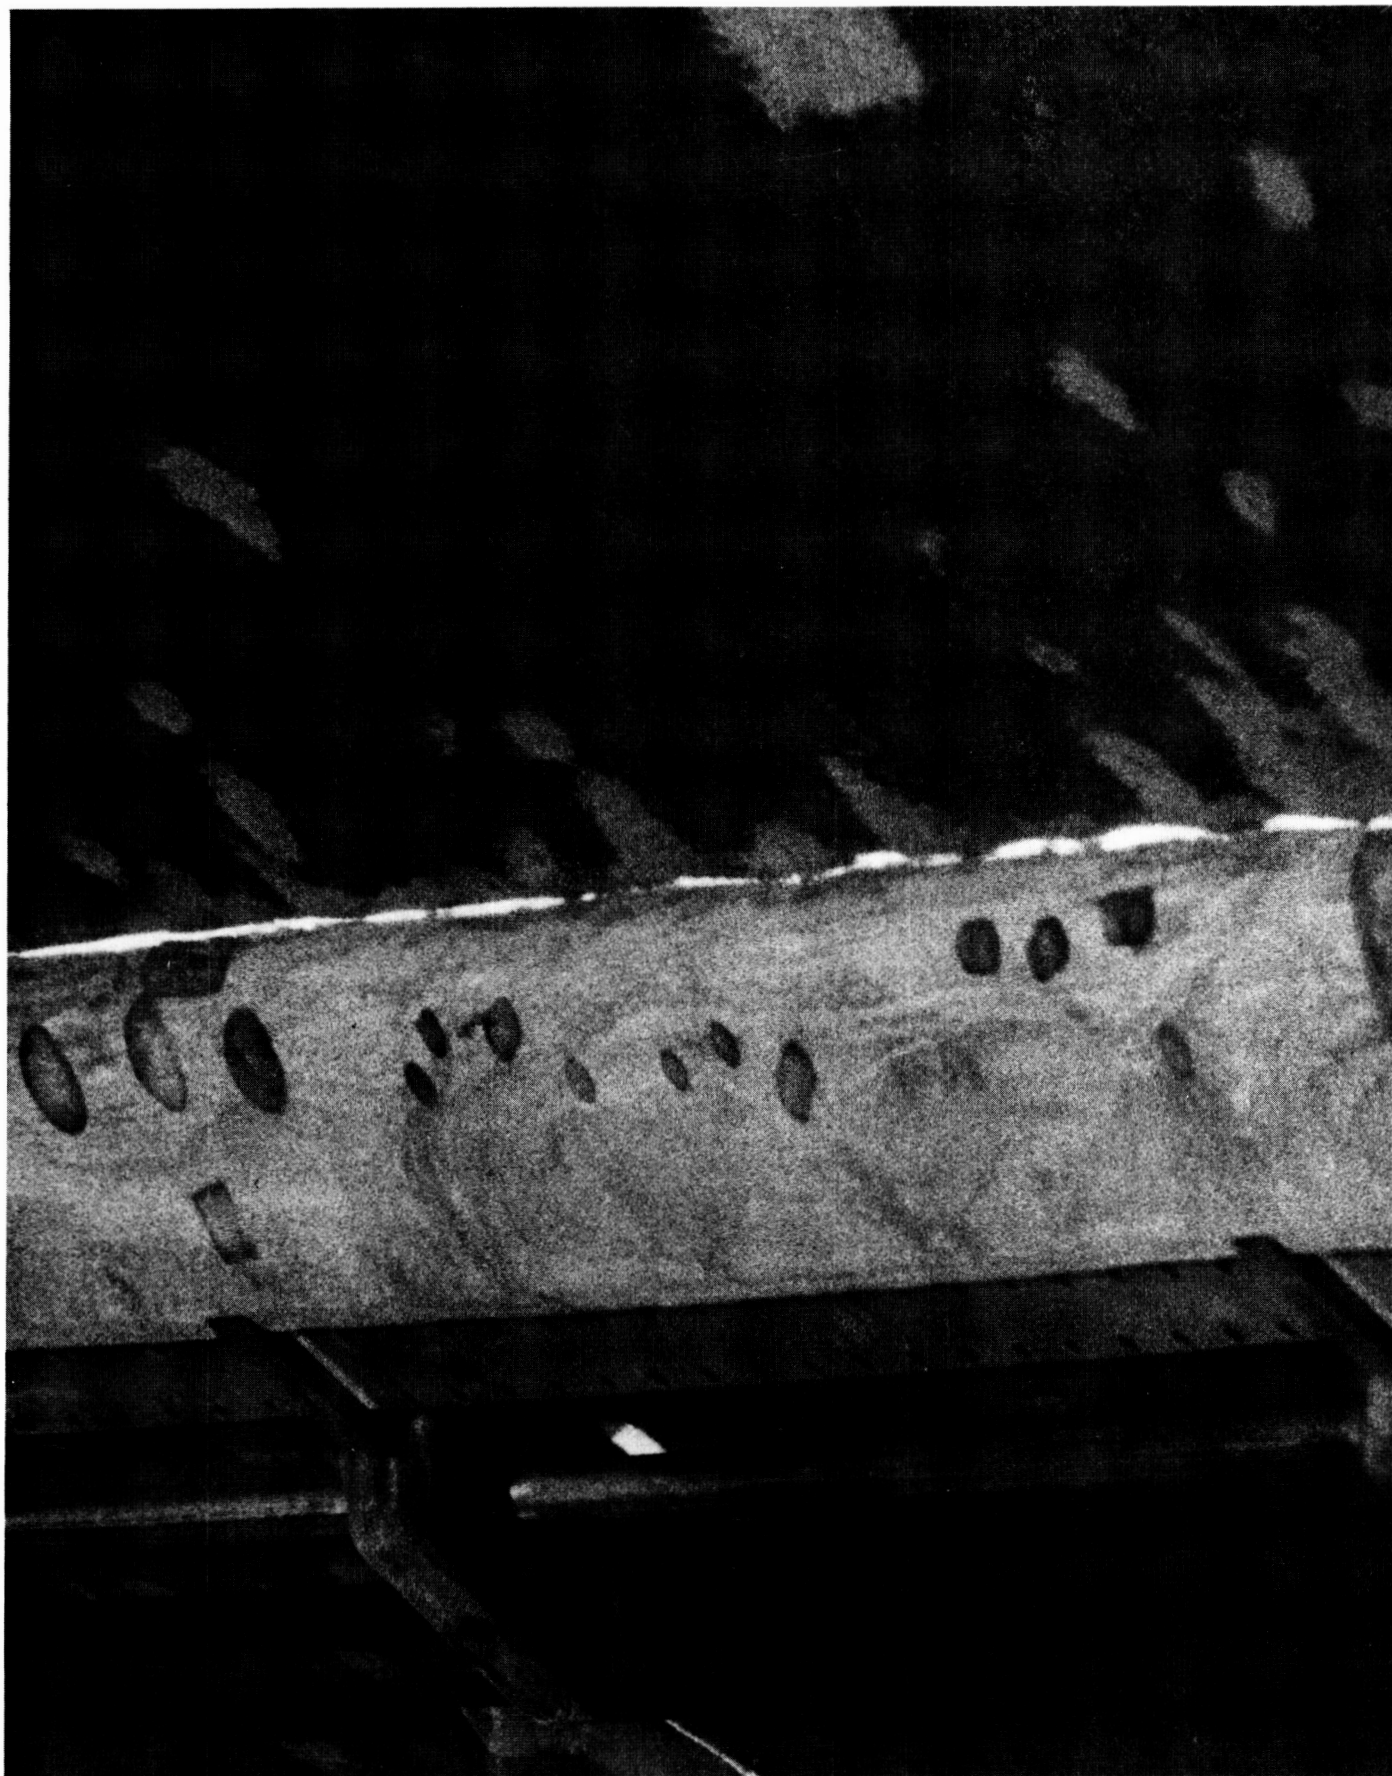
FROST AT LH2 PAL RAMP TO ACREAGE INTERFACE
AND AFT OF GOX PRESSLINE BARRYMOUNT

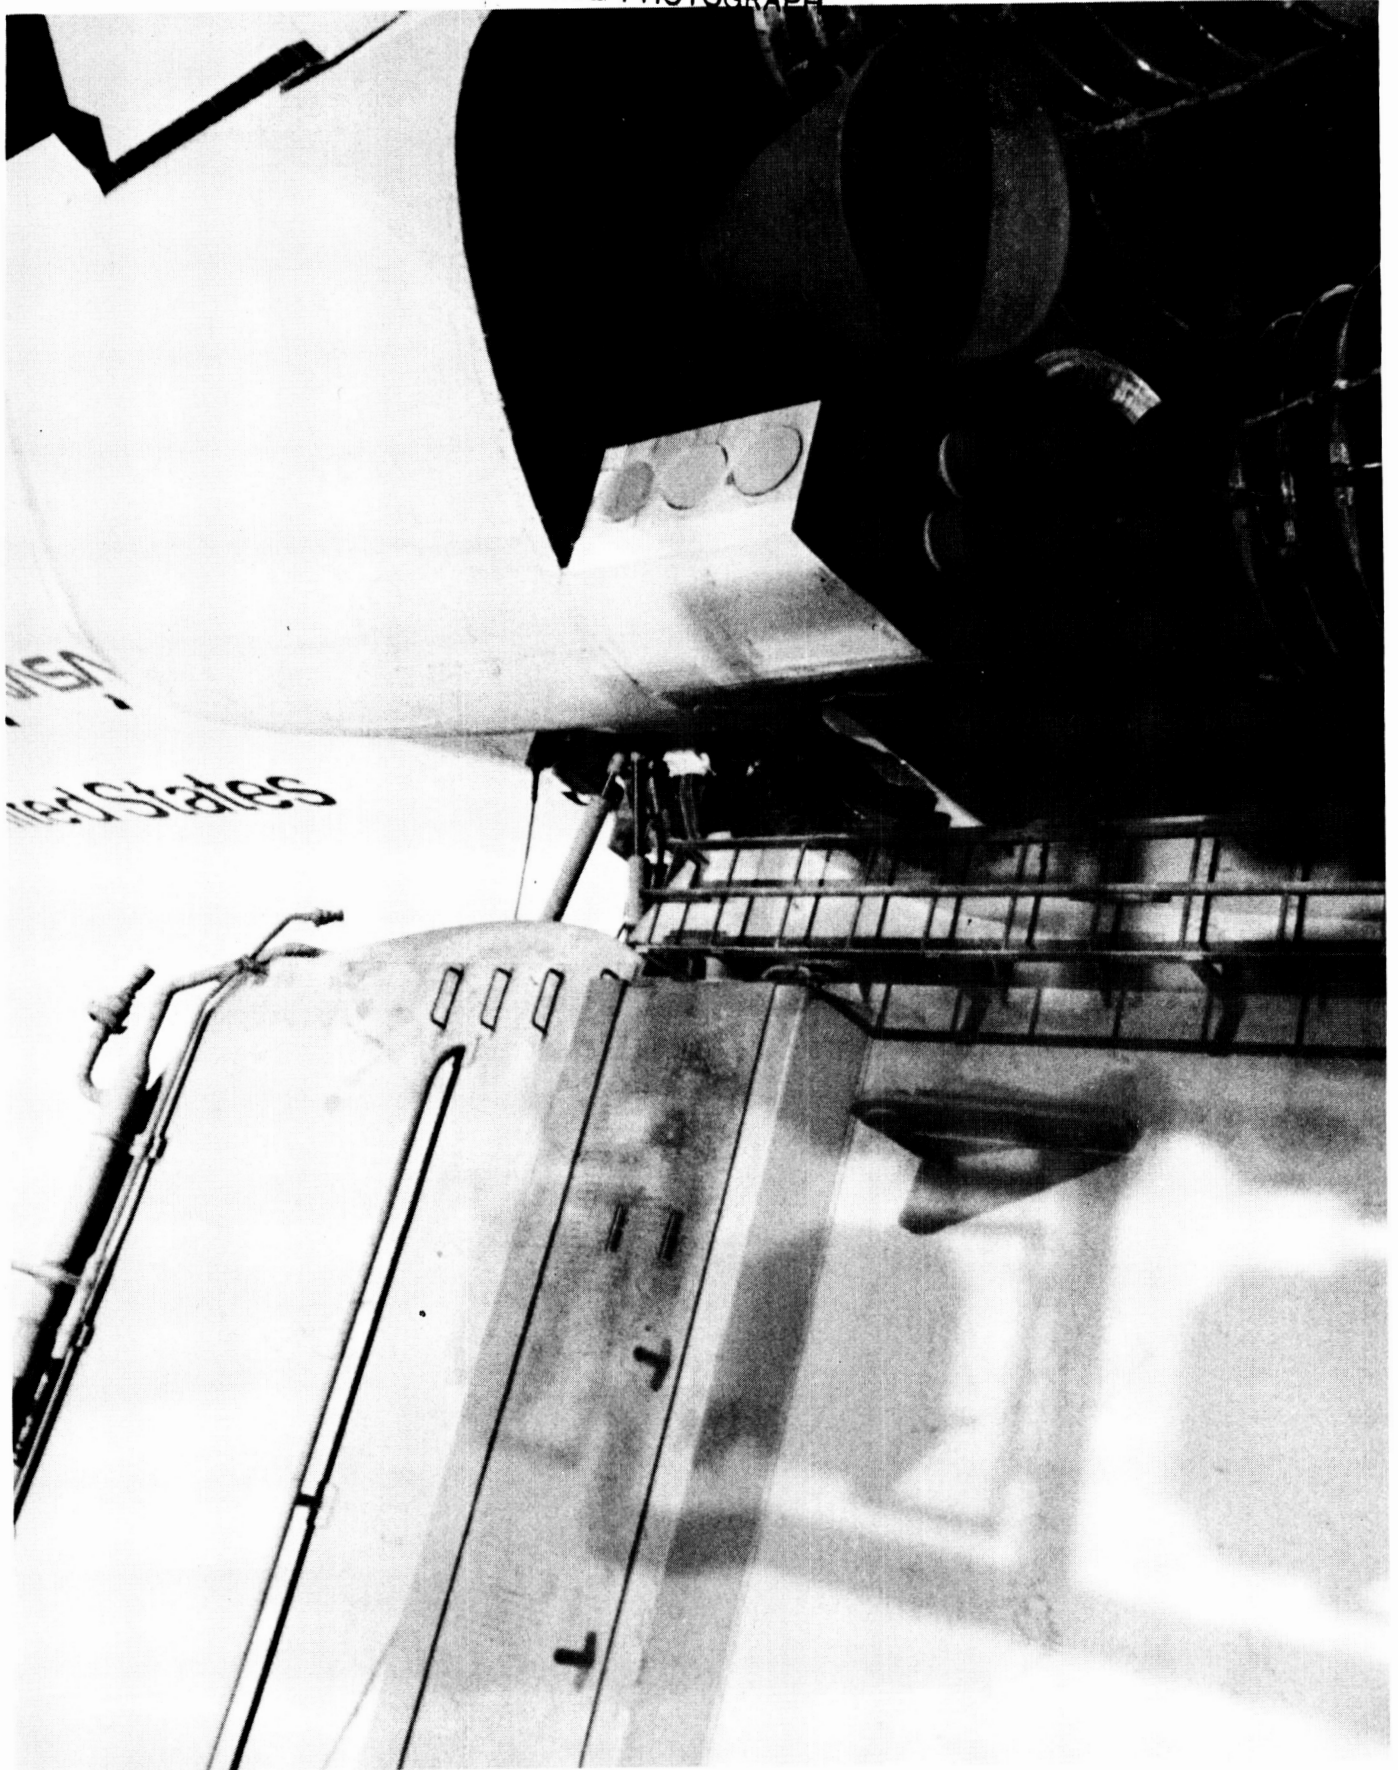
NO ANOMALIES VISIBLE ON TSM/ORBITER LH2 T-0 UMBILICAL.
DISCOLORED RCS COVER VISIBLE ON +Z SIDE OF LH OMS POD STINGER.

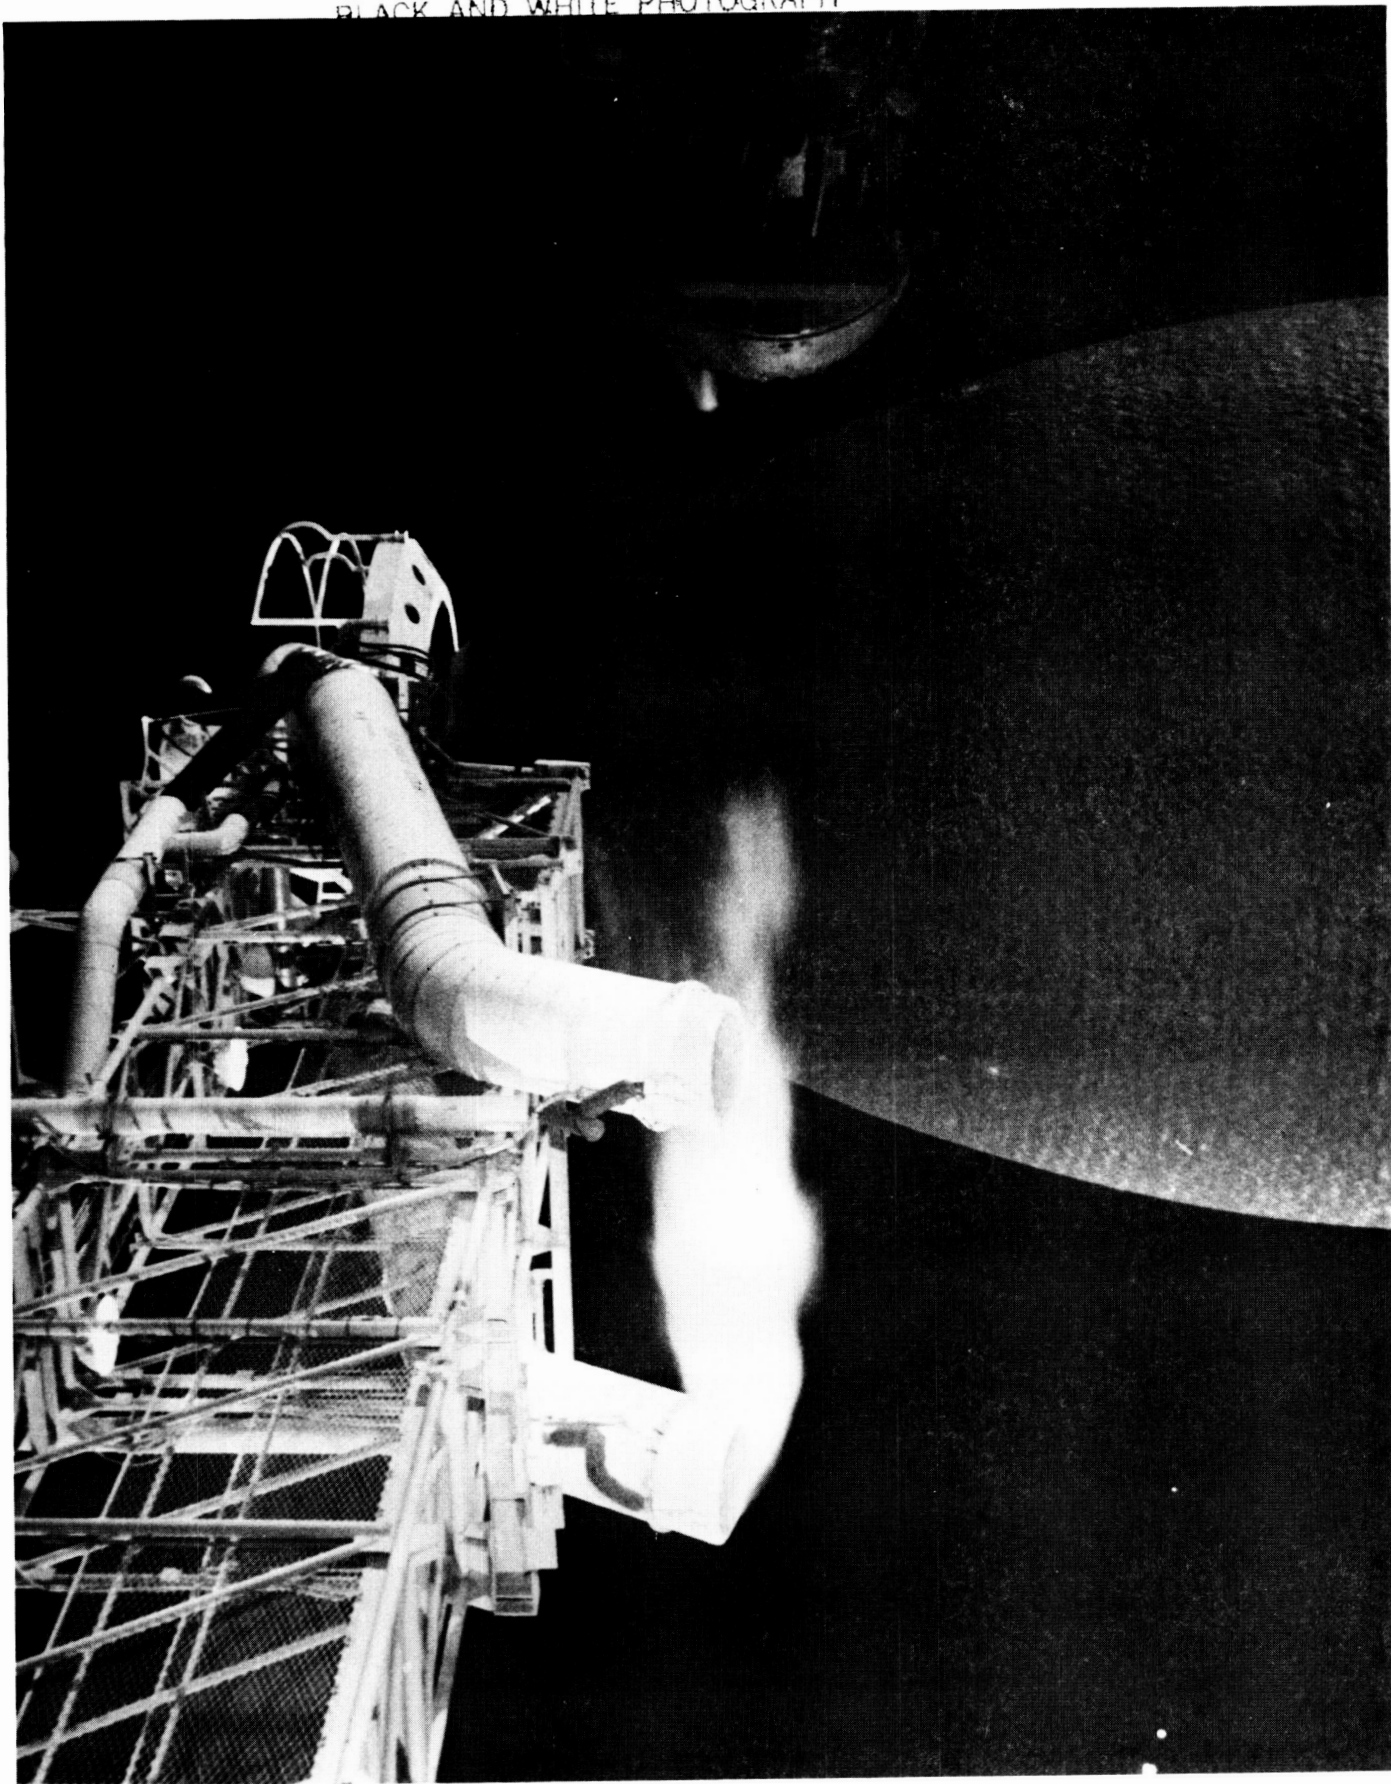
NO ICE/FROST ON -Y SIDE OF ET LO2 TANK OGIVE. THE NORTH
GOX DUCT IS VENTING MUCH MORE THAN THE SOUTH DUCT.

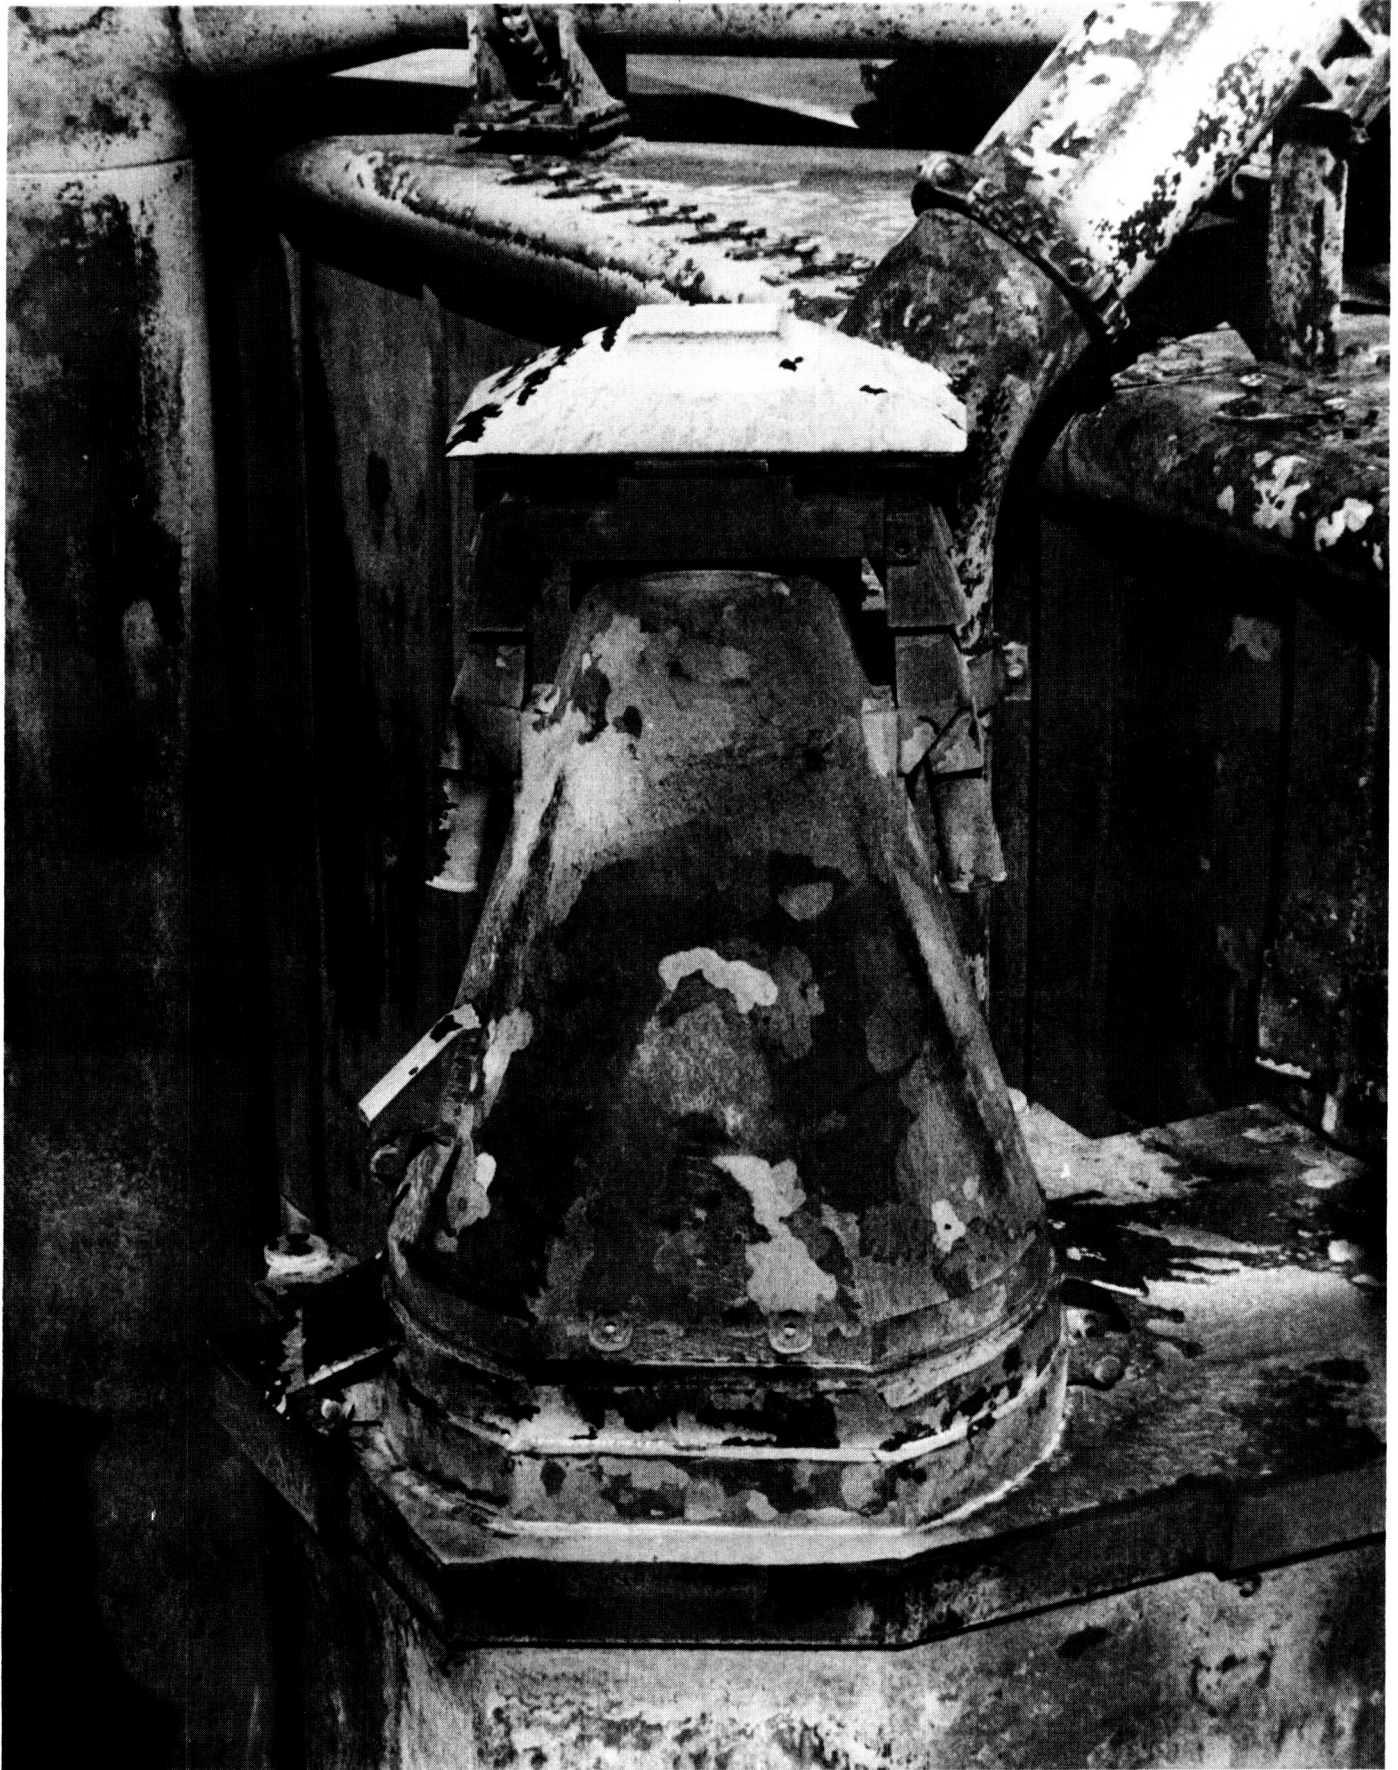
NORTH HOLDDOWN POST EXHIBITING MINIMAL POST LAUNCH DAMAGE.
DOGHOUSE BLAST COVER CLOSED NOMINALLY.
